# Manhole Inspection Summary

Manhole # S19II\_020MH

Insp Date: **6/20/07 12:37 PM**

**Location** Address: **1624 PULASKI ST**

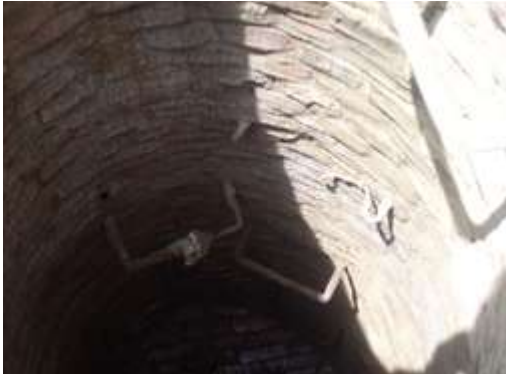
Defect 3

Count: **5** Missing: **3** ☒ **Corroded**

☒ **Evidence Of Surcharge** Depth: **6** (ft.) ☐ Active Surcharge Present

CORRODED AND MISSING STEPS,  
SURCHARGE EVIDENCE ON THE  
STEP

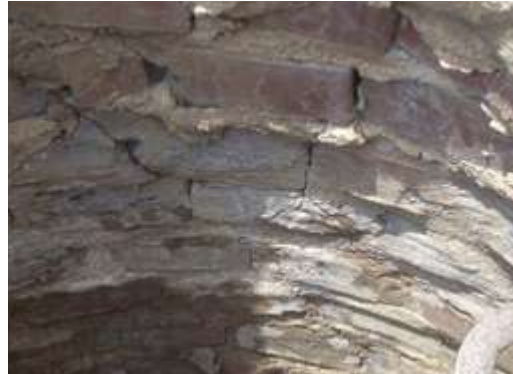
Defect 2

Condition: ☐ Sound ☒ **Cracked** ☐ Root Intrusion ☐ Loose Brick ☐ Deteriorated

CORBEL IS CRACKED

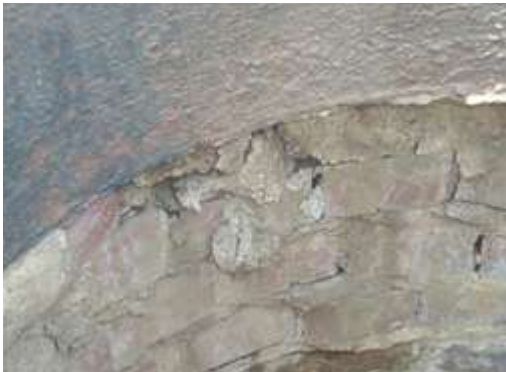
Defect 1

Condition: ☐ Sound ☐ Cracked ☐ Root Intrusion ☐ Loose Brick ☒ **Deteriorated**

DETERIORATED CHIMNEY

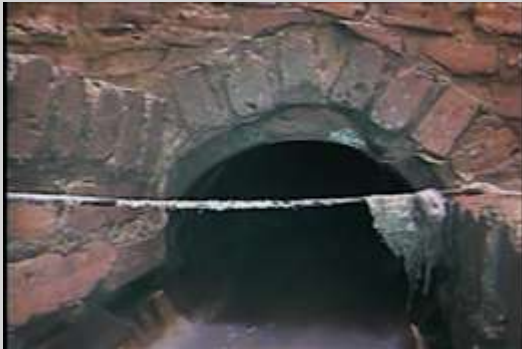
12 O'Clock Outflow

Pipe Height: **15.6** (in.) Rod and Bar (Angled)  
Pipe Material: **Clay** ☐ Pipe Lined  
Invert Depth: **13.62** (ft.) Flow Characteristics: **Fast**  
Deposits: ☒ None ☐ Mud ☐ Sludge ☐ Debris ☐ Grease  
Silt Depth: (in.) Deposits Extent:  
Infiltration: **None** Pipe Seal Cond: **Broken**

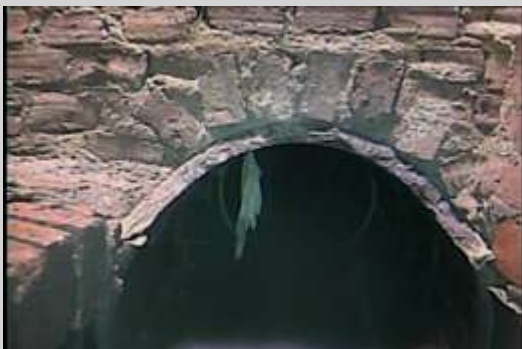
6 O'Clock Inflow

Pipe Height: **14.4** (in.) Rod and Bar (Angled)  
Pipe Material: **Clay** ☐ Pipe Lined  
Invert Depth: **13.60** (ft.) Flow Characteristics: **Fast**  
Deposits: ☒ None ☐ Mud ☐ Sludge ☐ Debris ☐ Grease  
Silt Depth: (in.) Deposits Extent:  
Infiltration: **None** Pipe Seal Cond: **Broken**
